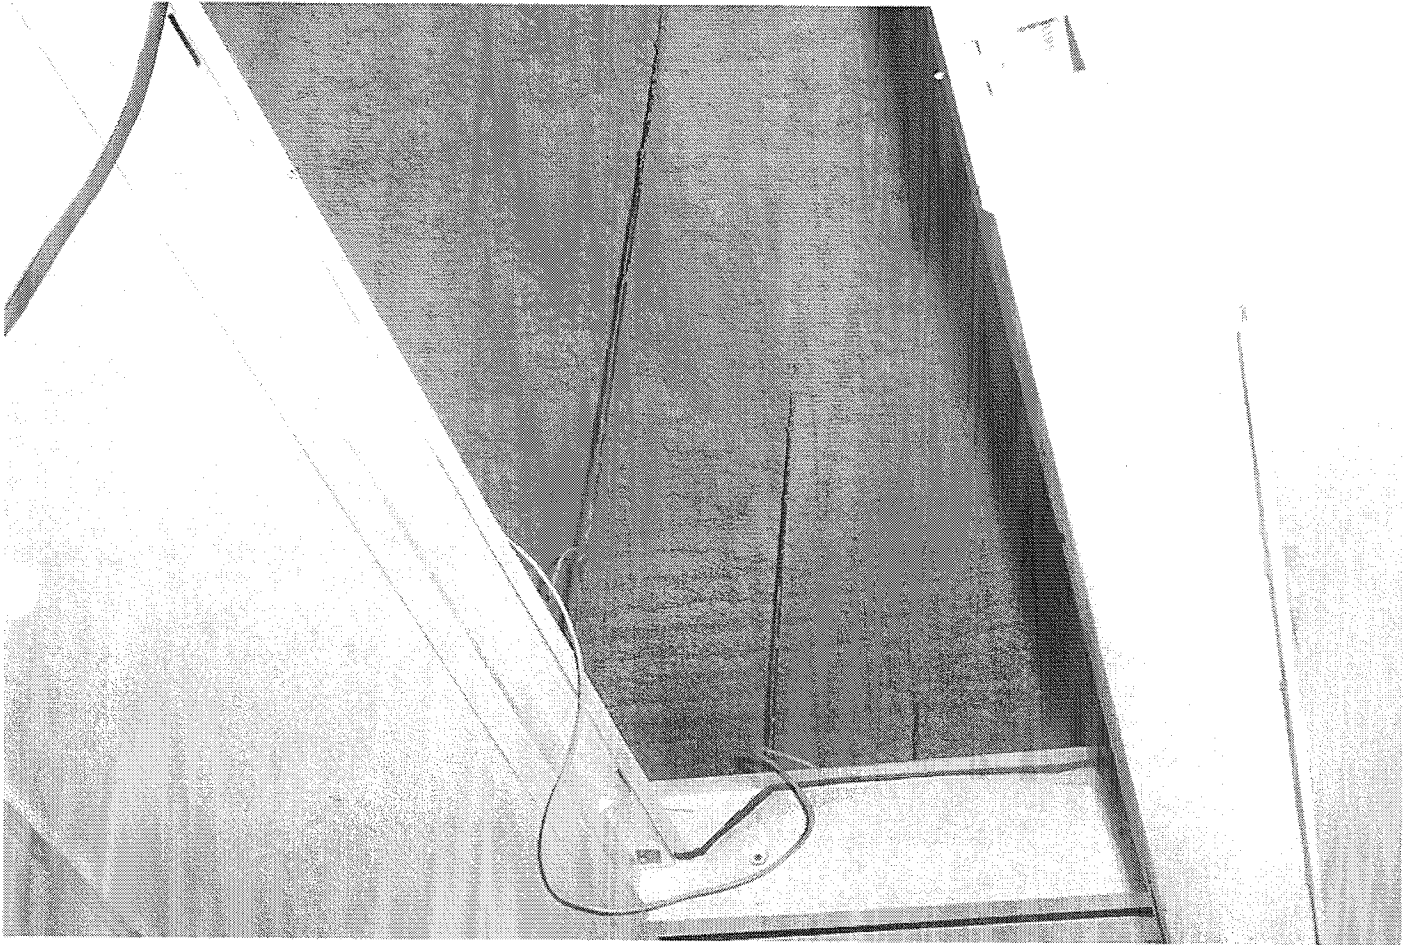
46. 12th floor, adjacent to room E1244A - General view of fireproofed sprayed decking above suspended ceiling

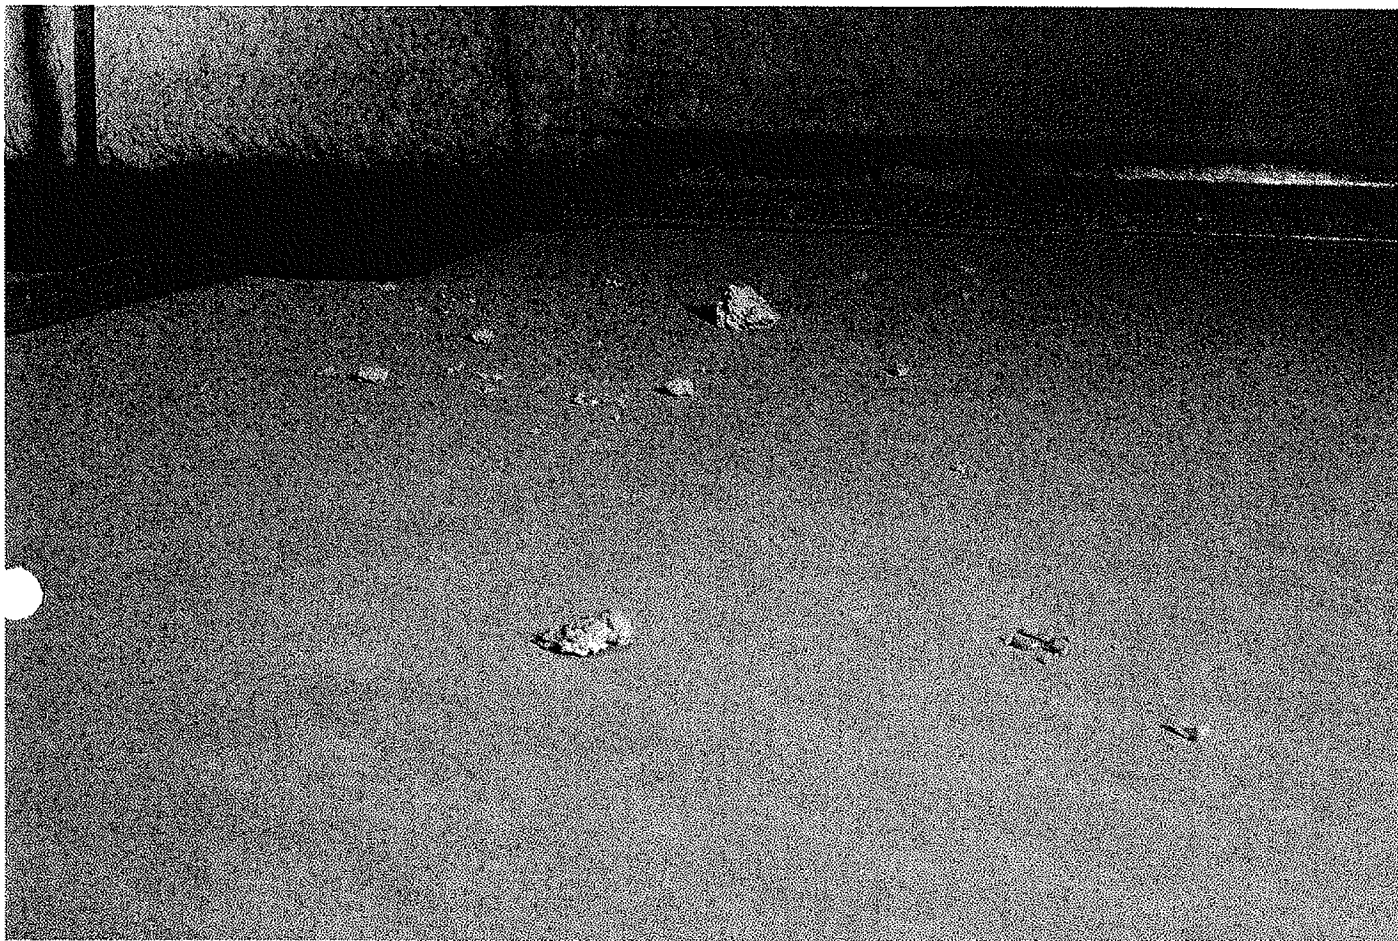
47. 6th floor, adjacent to room S601 - View of delaminated fireproofing debris on top of suspended ceiling

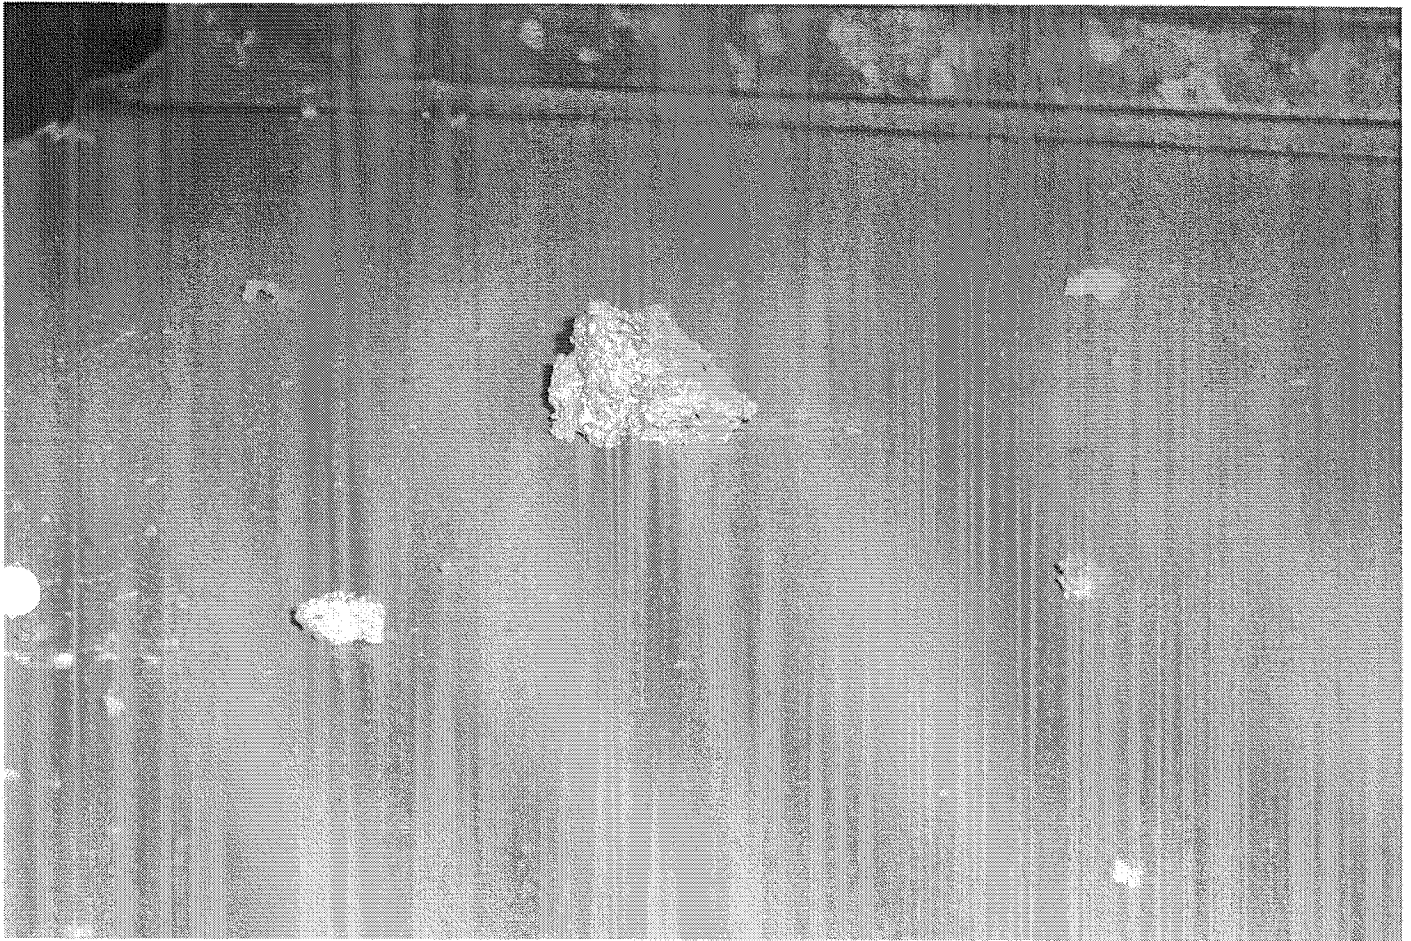
48. 6th floor, adjacent to room S601 - Close-up of delaminated fireproofing debris on top of suspended ceiling

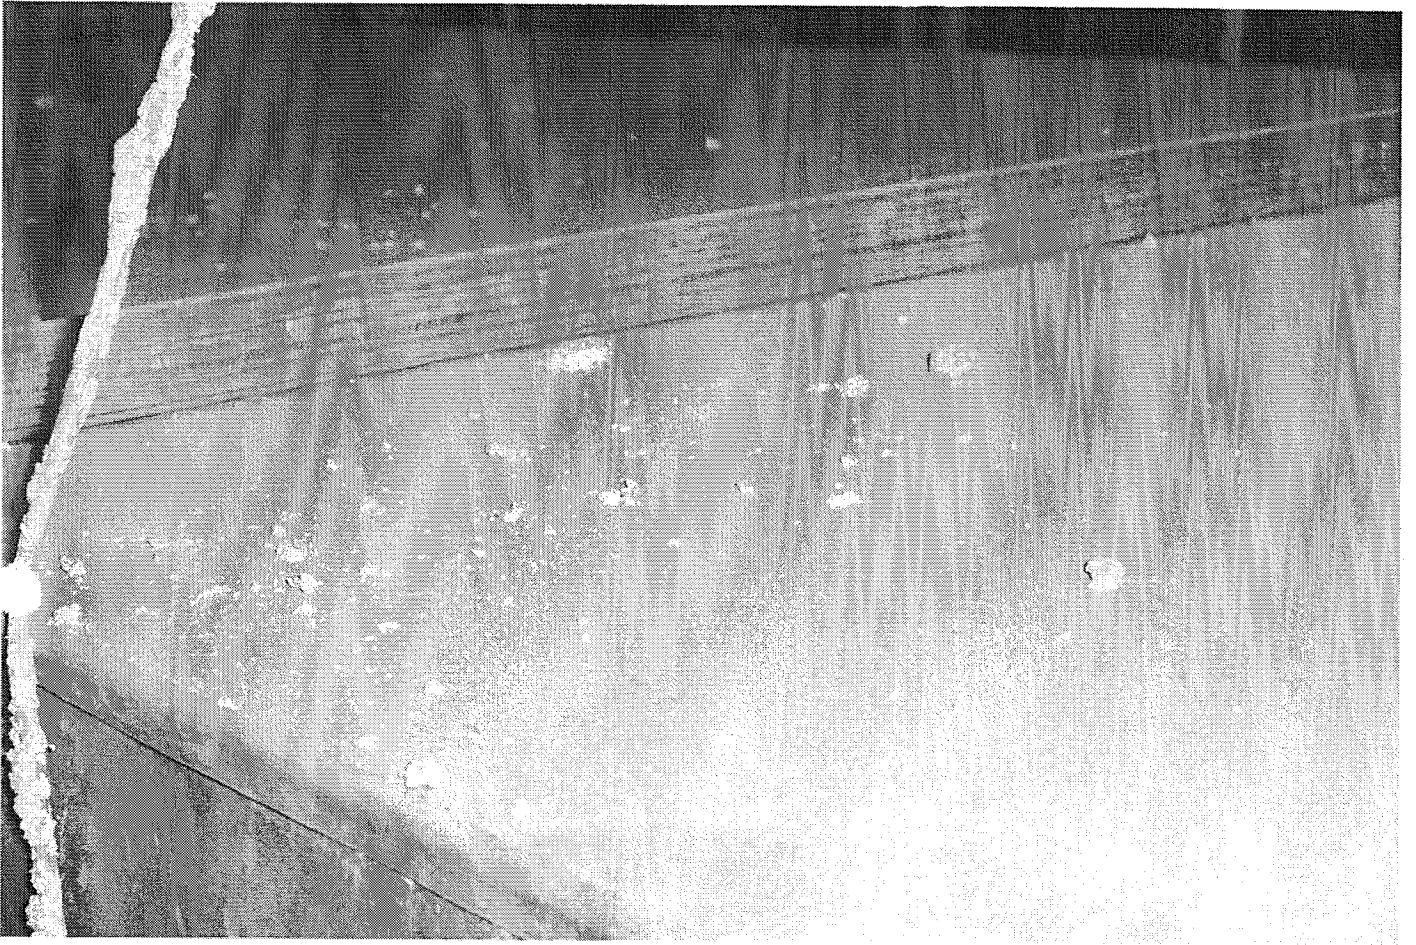
49. 6th floor, adjacent to room S601 - View of delaminated fireproofing debris on top of suspended ceiling

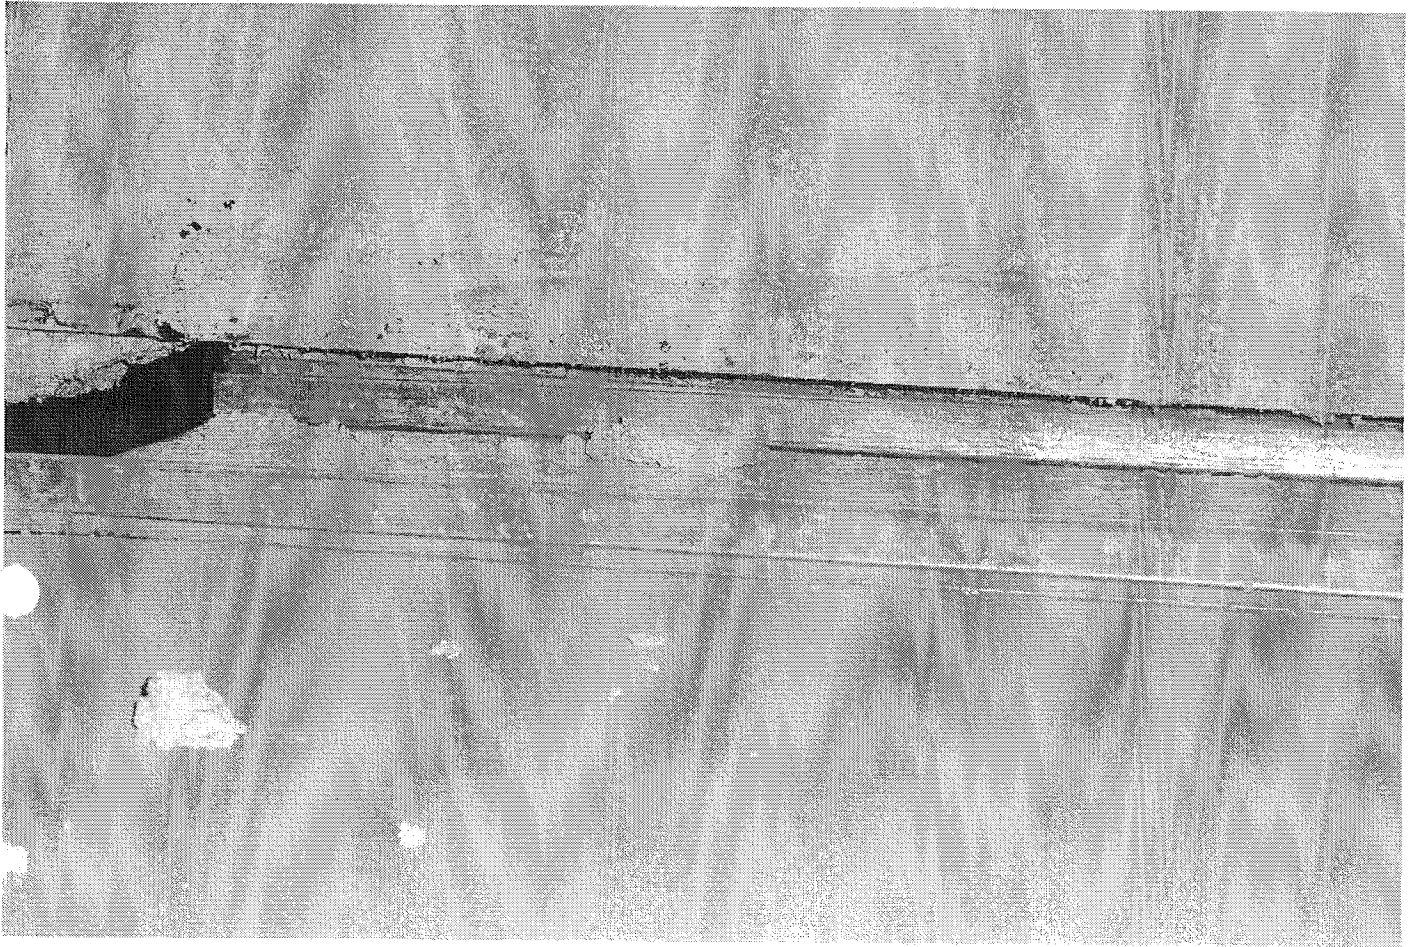
50. 6th floor, adjacent to room S601 - View of delaminated fireproofing debris on top of suspended ceiling
